# A Review of Stage 0 Restoration Practices in California and Oregon

Charlie Schneider  
Rebecca Flitcroft  
Guillermo Giannico

ORESU-T-22-002

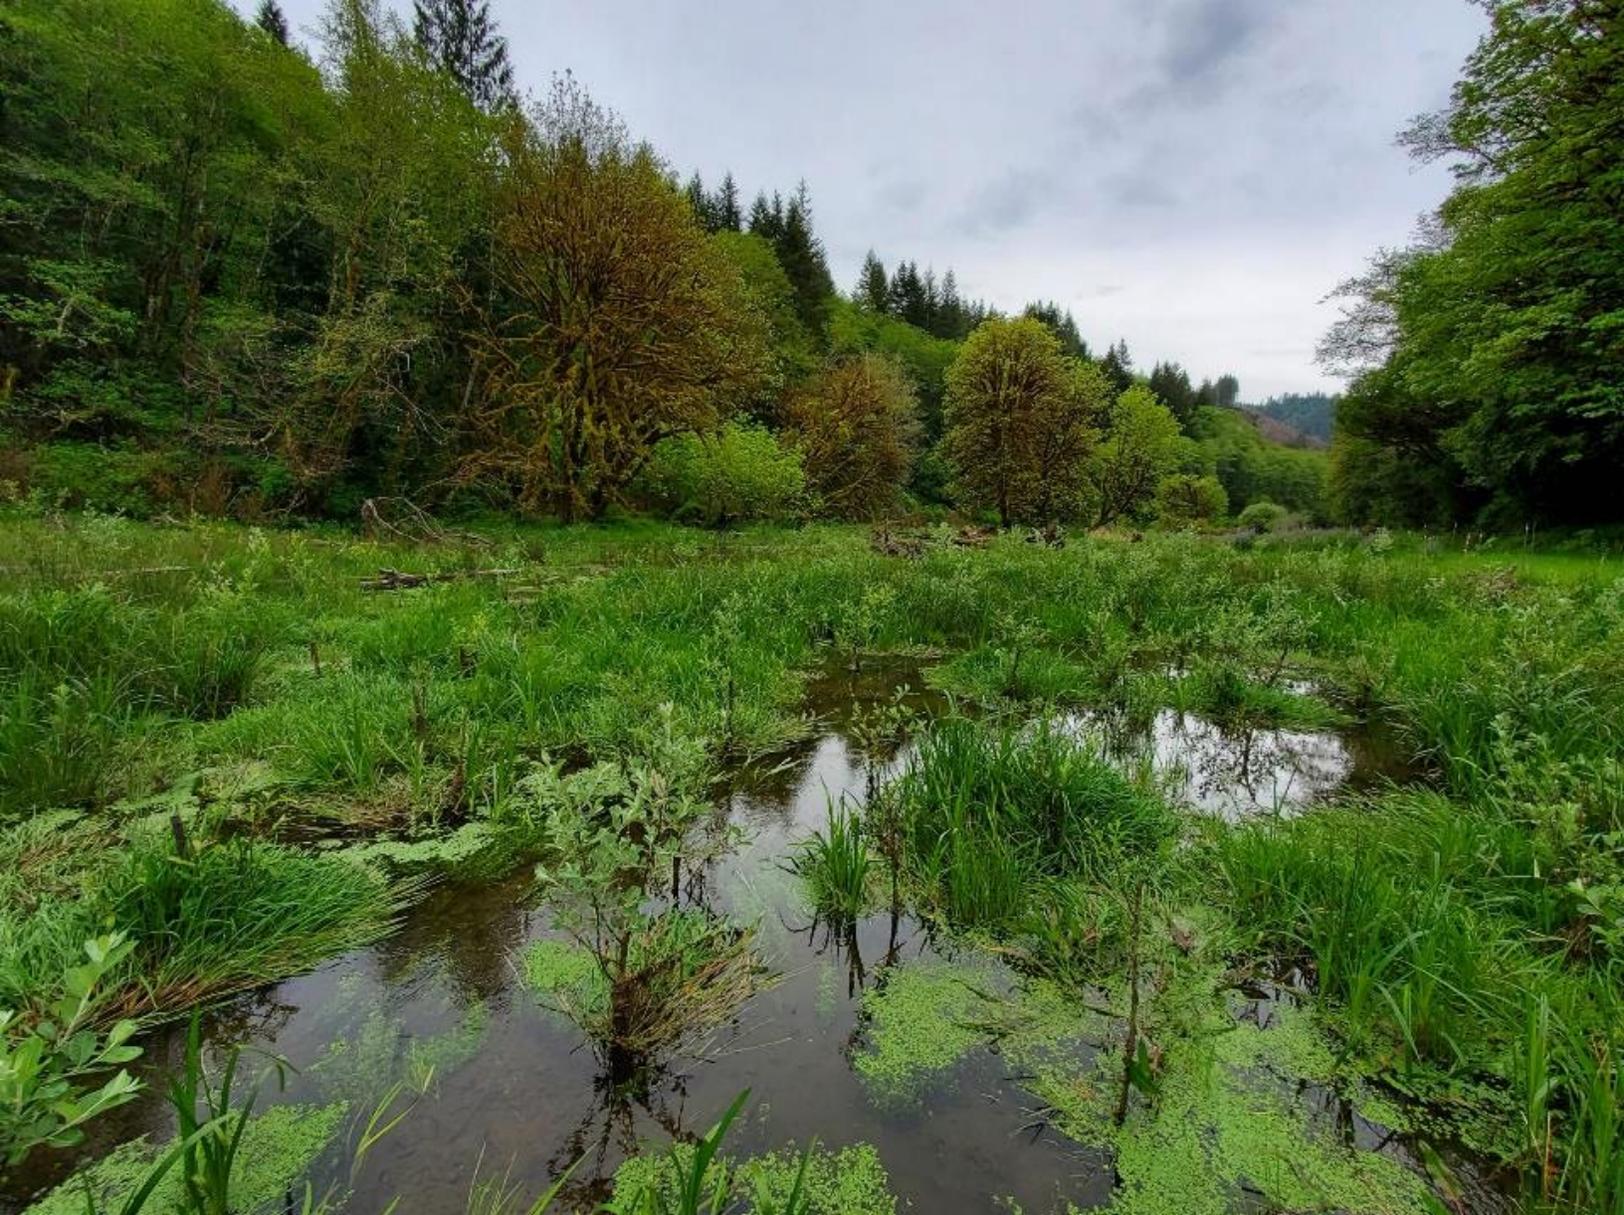
*Above: This is how the Five Mile Bell project south of Florence, Oregon, looked in May 2020 after implementation. (photo by Paul Burns of the Forest Service)*

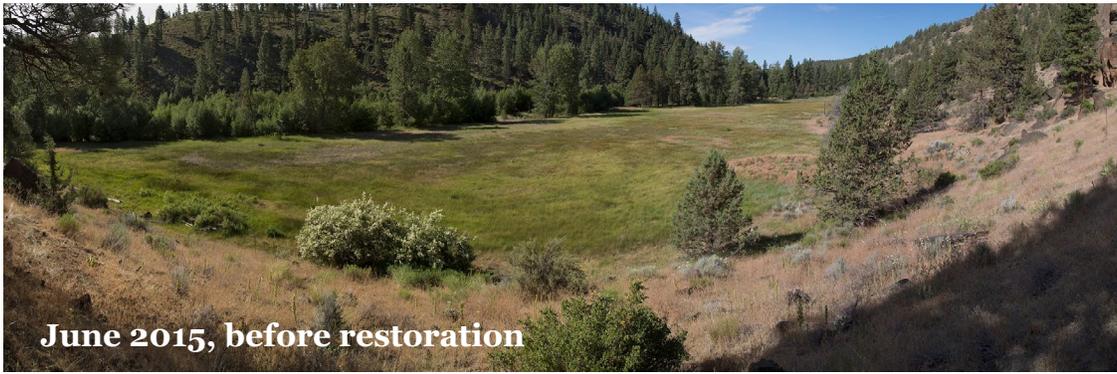
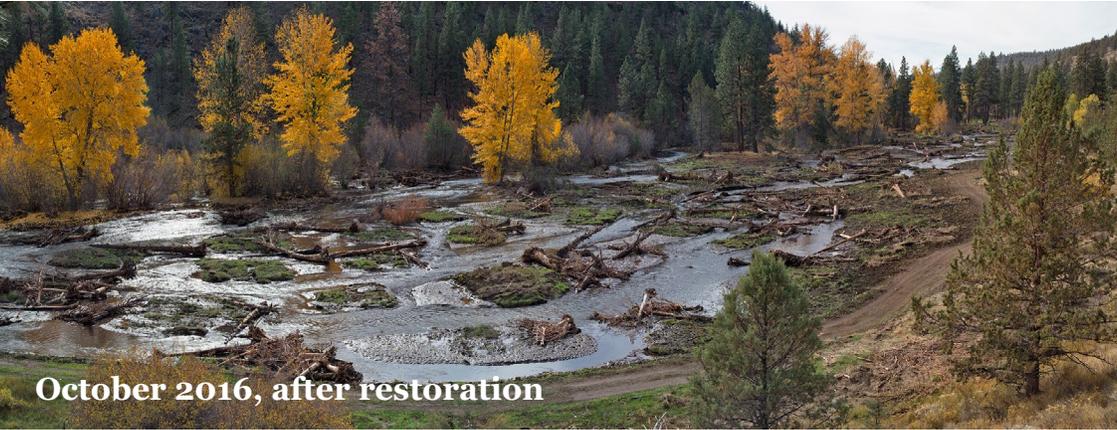
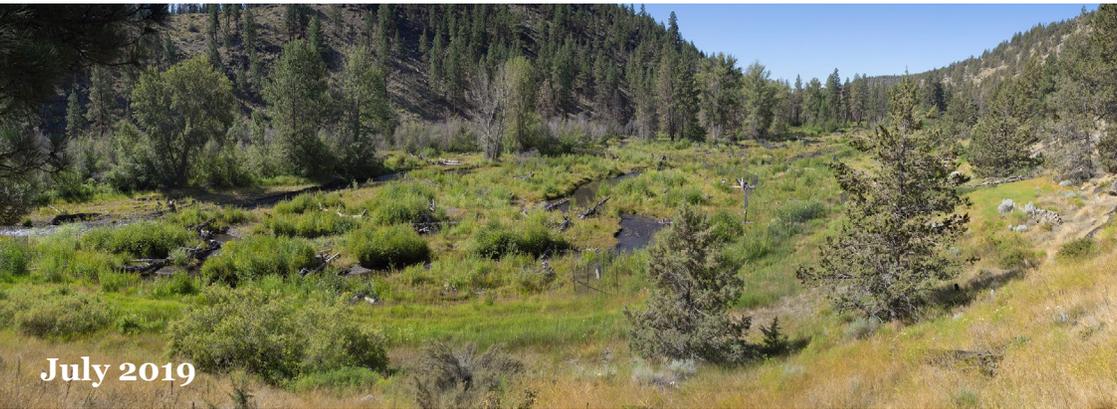
*Image 1: Over three years, Jay Mather, a volunteer photographer for the Deschutes Land Trust, photographed the same spot at the Whychus Canyon Preserve to document change.*

Photos were available for each project analyzed. They consisted of opportunistic captures, time-lapse series from trail cameras, shots from fixed photo points (Image 1), and images from camera-equipped drones (Figure 4). Drone photography was used to document a 20% increase in riparian vegetation cover classes at Whychus Creek one year after implementation (Perle 2019).

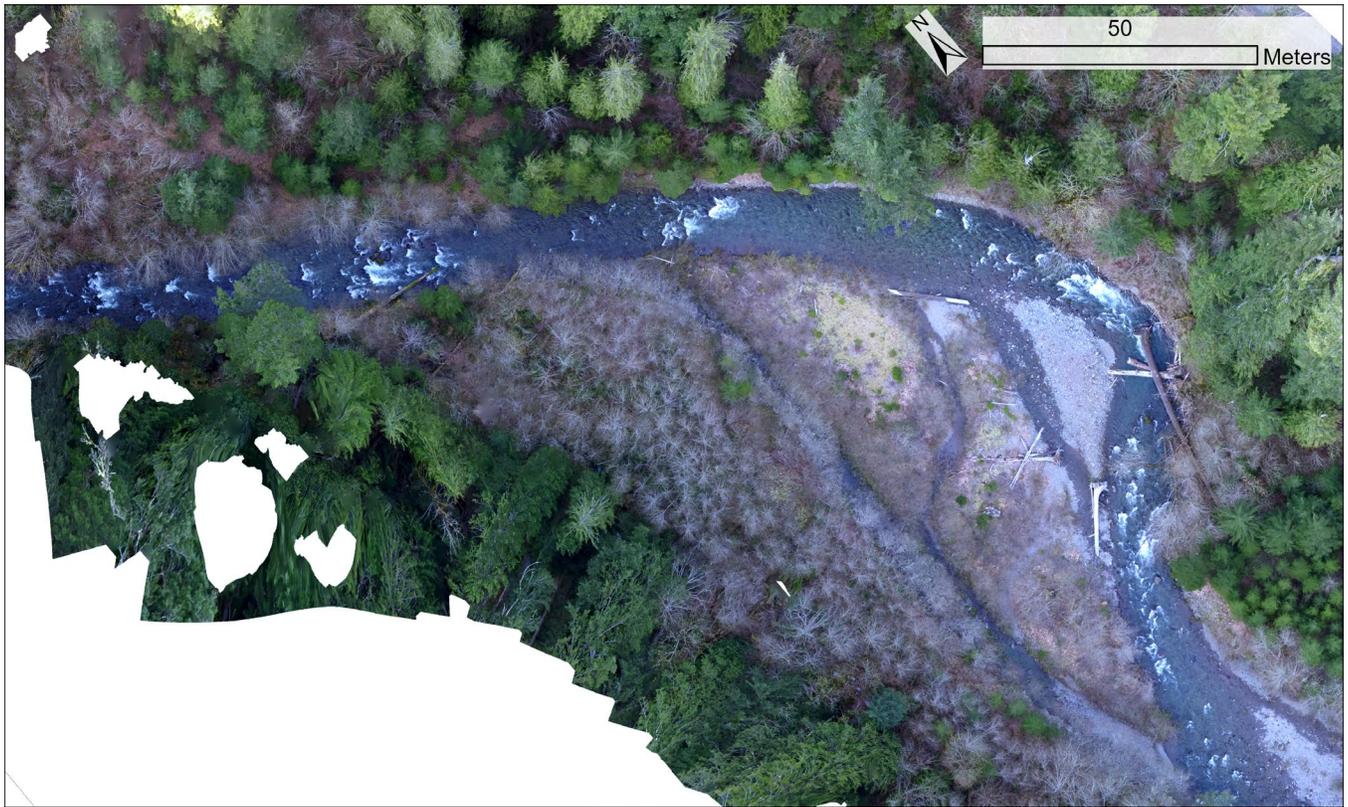
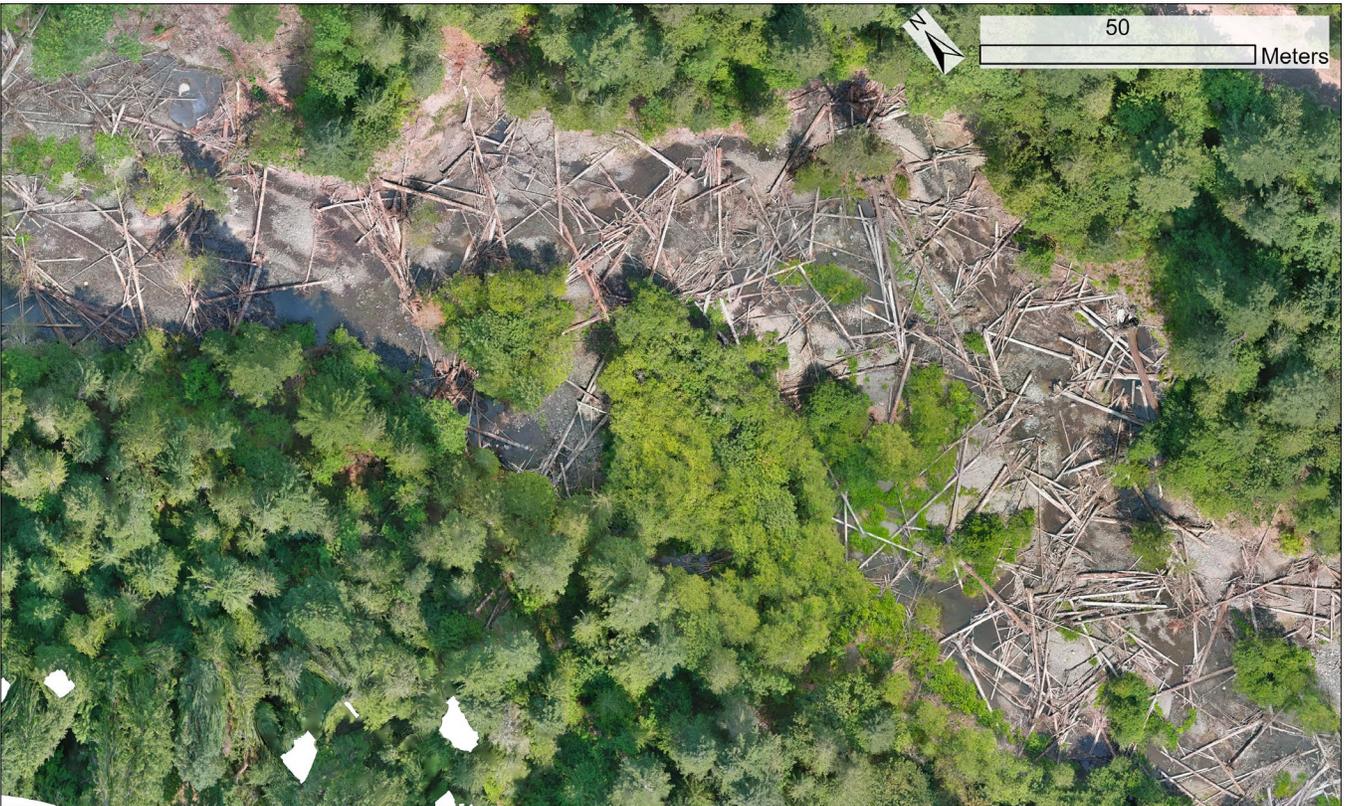
*Image 2: Dan Scott, a river scientist at the University of Washington, used a drone to photograph Deer Creek in 2016 before restoration (top) and in 2021 after restoration (bottom).*

Scott and Collins (2019) coupled aerial photos with field surveys in an attempt to document Deer Creek before and after the project (Image 2). Although they noted that management actions increased wood loading and habitat heterogeneity, Deer Creek had not been subject to a large enough flow event to naturally adjust the project site at their time of reporting.

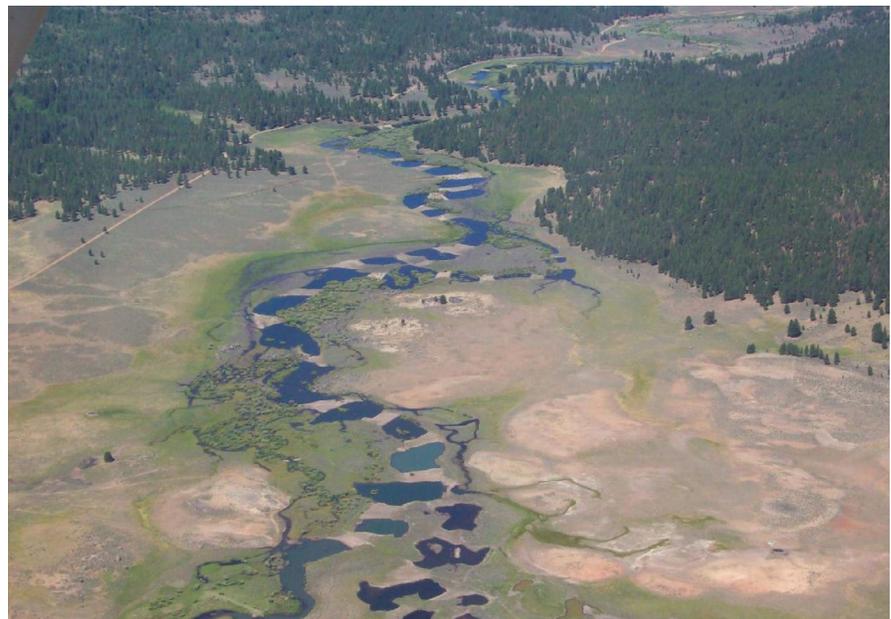
*Image 3: Pond-and-plug floodplain restoration on McReynolds Creek in the Sierra Nevada mountains in California (from Wilcox 2010)*

to achieve a stage 0 stream condition have been used, the foremost being the pond-and-plug technique (Image 3) used in montane meadow restoration efforts (Rosgen 1997).
